# Flood hydrology of the Storms River tubing accident

K D Hogan

***In March 2000, 13 people died in a tubing accident on the Storms River. The reasons given in the media for the accident were 'freak flood' and 'flash flood in side kloof', which were considered to be acts of God. A study of the hydrology of this river and the surrounding rivers found this to be untrue. The rainfall records indicated significant widespread rainfall over the whole Tsitsikamma area during the accident period. The historic rainfall records indicated that rainfall of the magnitude experienced over the accident period had a recurrence interval of three times a year on average. The water-level records from three nearby gauging stations showed a good correlation between them and are a good indication of the water level in the Storms River during the accident period. The historic records of these gauges indicated that a flood of the magnitude experienced during the accident was likely to occur two to three times a year on average. An understanding of the hydrology of the river may have resulted in the river guides making a different choice when confronted with the flood in the major tributary, thereby savi

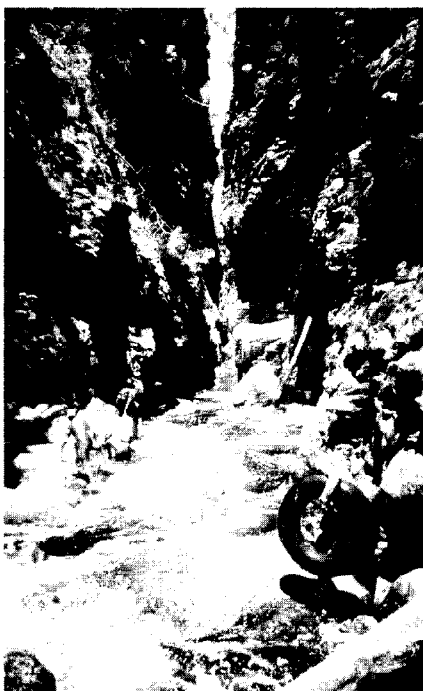
Figure 3 Tubers in narrow section of gorge during low flow conditions (Photo by Gill Manley)

and continue down through the narrow gorge section, ending at the river mouth. If the water level is high, the narrow gorge section is extremely dangerous and tubing down the river is prohibited. However, if the water level is considered 'medium high', the commercial company which uses river guides to take inexperienced tubers down the river, is allowed to go down the river as far as the emergency exit or escape route, which is just before the dangerous narrow

gorge section, and about 500 m below the confluence with the Witteklip River.

On the morning of 25 March 2000, three large groups of rafters were booked to go down the river with the commercial company. Heavy rain had fallen in the early hours of that morning, and there was some debate as to whether to continue with the planned river trips. Finally, all three groups did enter the river, the final group leaving relatively late in the morning, despite the continual rain. In spite of the rain, the water level in the river was not considered abnormally high at that stage. The first two groups successfully completed tubing the river, exiting at the escape route. The final group, however, somewhat slower than the other groups, found on reaching the confluence with the Witteklip River, that the tributary was significantly flooded, noticeably swelling the water in the Storms River. Instead of taking the inexperienced tubers off the river at this stage, the guides opted to continue the last half a kilometer to the emergency exit where arranged transport was waiting for them. Unfortunately from that point on, the water level in the Storms River itself apparently rose rapidly and significantly, with the result that the river guides were unable to control the group of inexperienced tubers, and a number of tubers and guides were swept into the dangerous narrow gorge section, where most died (*Eastern Province Herald*). Figure 3 shows what the narrow section of the gorge looks like when the water level is low.

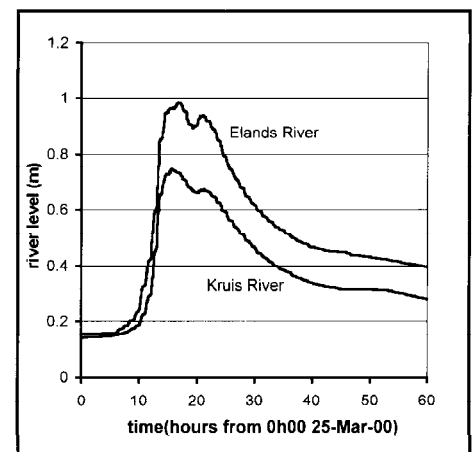
Figure 5 Water level record in Elands and Kruis rivers during accident period

The Elands and the Kruis rivers recorded similar rises in water level, (approximately 1 m in Elands and 0,75 m in Kruis) although over a longer time period of about eight hours, starting at approx 8am with the peak at 4pm. The steepest rise was from 12am to 2pm in both rivers. The peak runoff recorded in the Kruis and Elands rivers was 17,7 m<sup>3</sup>/s and 17,9 m<sup>3</sup>/s respectively. The rise in water level in the Elands and Kruis rivers over the period 25–27 March 2000 can be seen in figure 5. Note the very steep rise in water level over the accident period, 1–2pm on 25 March.

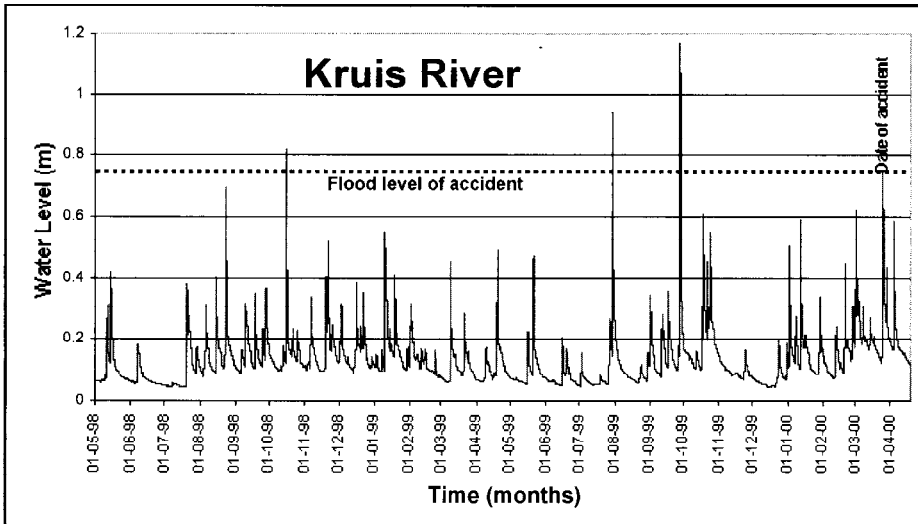
Figure 6 Water level record in Kruis River over period 1 May 1998 to 18 April 2000

In a study of the Elands and Kruis River gauging station records for the period October 1990 to January 2001 (the last ten years) (Department of Water Affairs and Forestry, Cradock), flood events of the magnitude of that recorded on 25 March 2000 or greater, have occurred 27 times in the Elands River and 34 times in the Kruis River. This is in the order of two or three times a year on average for both these rivers. Figure 6 shows the water level record from the Kruis River for the period 1 May 1998 to 18 April 2000 and illustrates this high frequency of floods. A similar occurrence occurred in the Bloukrans River (Department of Water Affairs and Forestry, Western Cape Region), with 24 flood events of the magnitude recorded on 25 March 2000 or greater, during the period January 1990 to December 2000. This is also in the order of two or three times a year on average. There is a good correlation of flood events between these three rivers and it can be expected that a similar recurrence of flooding would have been experienced in the Storms River, which lies between these rivers, ie floods of this magnitude may be expected in the Storms River twice or thrice in each year, on average. It can be seen in Figure 6 that the rise in water level is always rapid, and that floods greater than or equal to the magnitude experienced during this accident, occur frequently.
